# Manhole Inspection Summary

Manhole # S43G\_\_016MH

Insp Date: **6/6/08 11:49 AM**

**Location** Address: **203 bethel st**

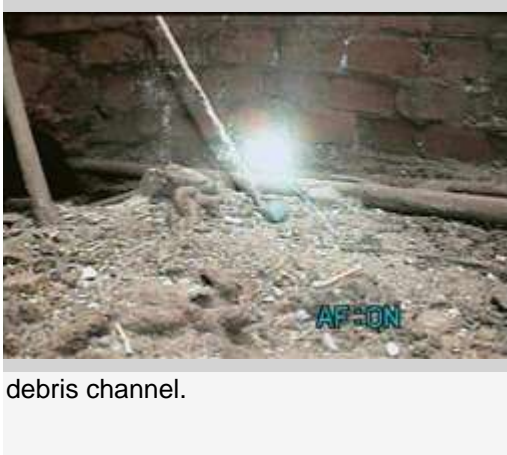
Defect 2

Condition: ☐ Sound ☐ Cracked ☐ Root Intrusion ☐ Deteriorated ☐ Leaks ☒ Debris

debris channel.

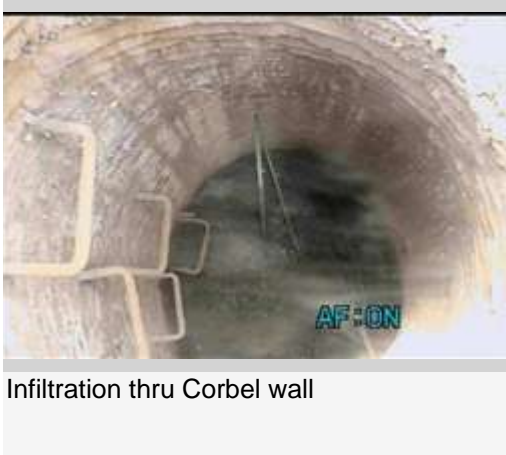
Defect 3

Infiltration: ☐ None ☐ Joint ☐ Cracks ☐ Mortar ☐ Roots ☒ Wall

Infiltration thru Corbel wall

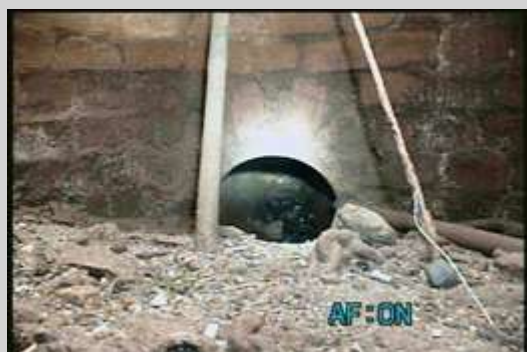
12 O'Clock Outflow

8 in. Circular Gravity Sewer  
Pipe Out @ 12 O'Clock
